Minerals Inspection Report

Mine Name: Rim Mine	Permit Number: M/037/0006	Mine Status: Inactive
Operator Name: Energy Fuels Resources (USA)	Inspection Date: 04/15/2014	Permit Fees: Paid
Inspector(s): M. Bradley	Inspection Time: 3:00p	Bond Amount: \$112,668
Attendee(s): See below	Weather: Pt. Cldy, cool	Bond Escalation: 09/21/2015
Inspection Purpose: Routine inspection		Prior Inspection: 07/24/2013

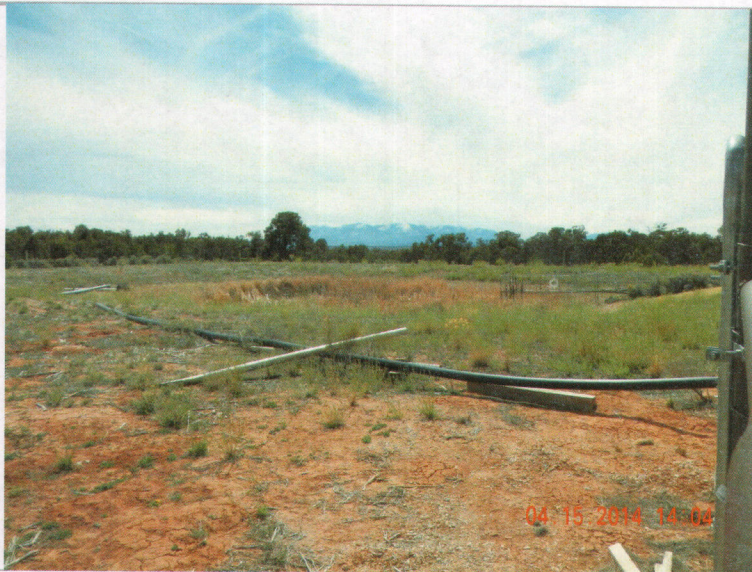
Waste water treatment pond #1

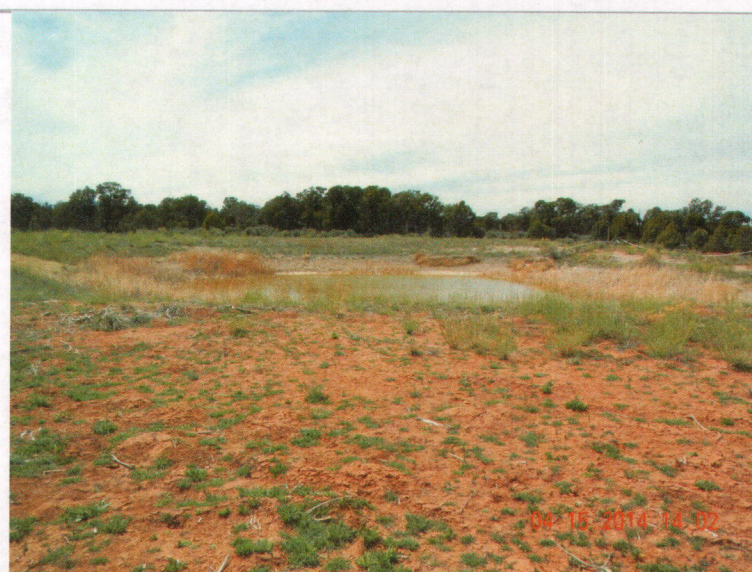
Waste water treatment pond #2

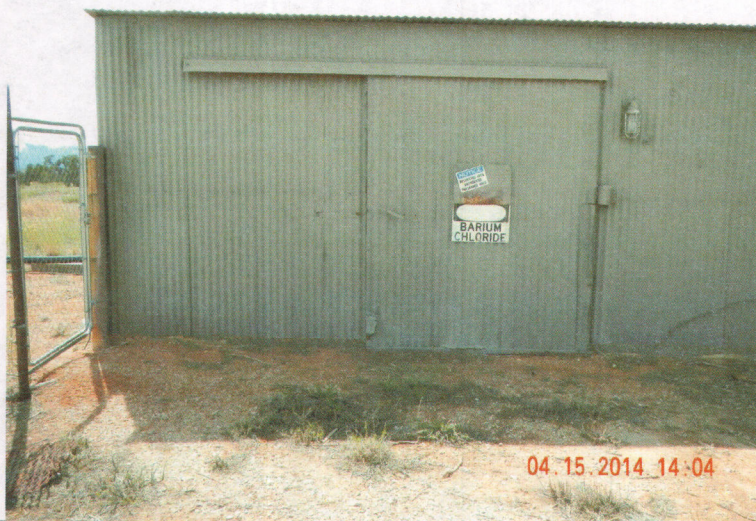
Waste water treatment building

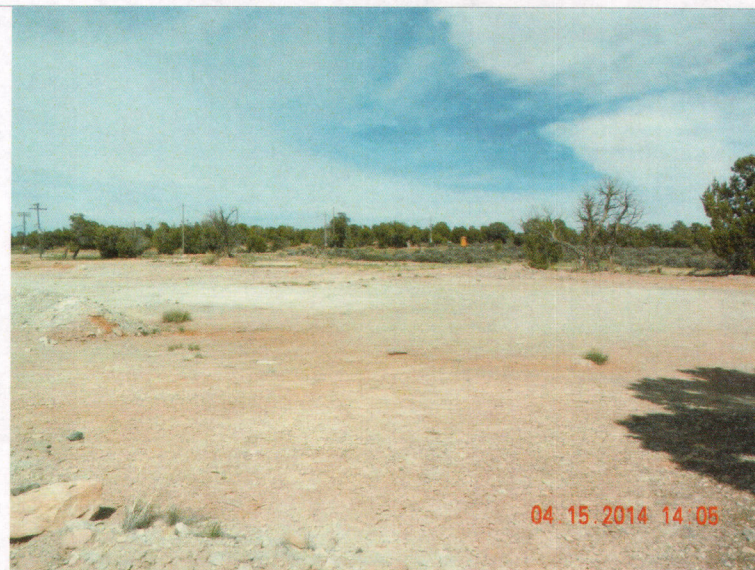
Southeast area of site that has been regraded. Yellow structure is vent shaft.

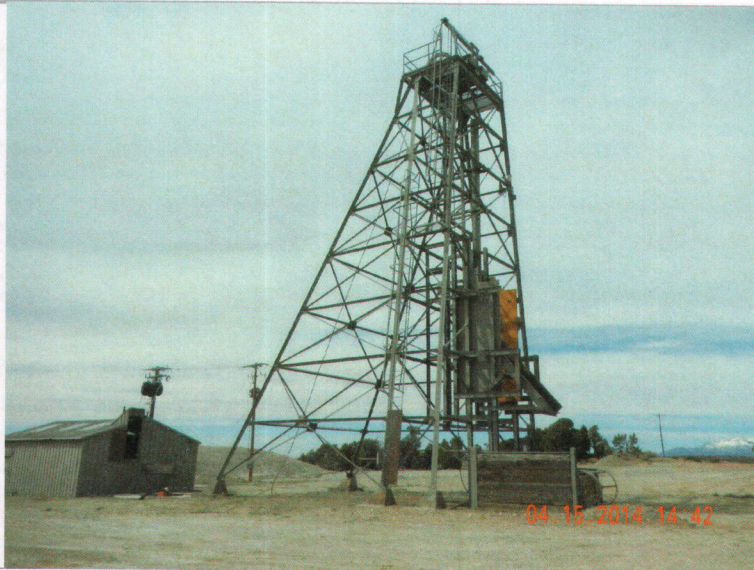
Head frame and hoist building
